Metal mesh dentures- A case report

Department of Prosthodontics, Navodaya Dental College & Hospital, Raichur, Karnataka

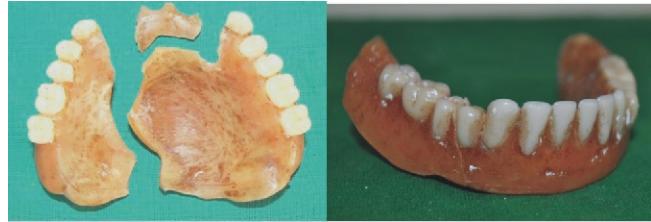
A 55 year old male partially edentulous patient with good general health, psychologically well and conscious of his appearance, with history of fracture of maxillary and mandibular dentures (Figure 1) reported to the department of prosthodontics, Raichur for prosthesis, history revealed that he was partially edentulous for the past 3 months and was wearing a denture since 2 months.

Figure 1. Fractured upper and lower dentures

Our objective was to enhance the fracture resistance of the denture. So, it was planned to fabricate cast metal denture, which was not cost effective for the patient. So keeping in mind the patient's concern about the cost and function, it was decided to fabricate a metal mesh denture. Considering the availability of the resources, it was planned to fabricate a metal mesh reinforced denture. The lower arch was completely edentulous.

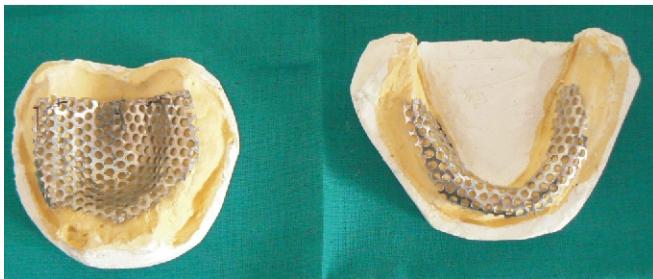
Figure 2. Metal mesh adapted to master casts

Duplication of the master cast with alginate was done. A dental stone cast was poured, which was used to adapt the metal mesh. A pen was used to mark the size of the reinforcing mesh. The mesh was cut using a carborundum disc. The reinforcing mesh adapts to the cast by using mallet and plier. The size was adjusted

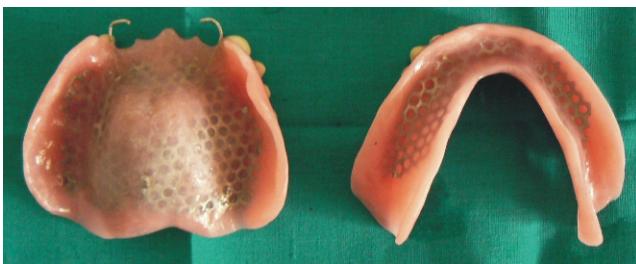
subsequently (Figure 2). The integrated reinforcing mesh must completely lie within the denture resin (Figure 3). Over dimensioning of the denture base is avoided owing to the small thickness of 0.4 mm of the mesh. The same mesh was incorporated during packing after following regular complete denture protocols. Denture insertion was done (Figure 4) and regular post insertion check ups were done.

Fig.3. Metal mesh incorporated upper and lower dentures

stomatitis but also sensitivity that results in eczema and dermatitis without mucosal manifestations. In the present study, a ready made mesh is used, it has holes for retention of the acrylic denture base which does not come in contact with the soft tissues and the small thickness of 0.4 mm of the mesh allows for easy manipulation and incorporation in the denture base without increasing its thickness.
